Lithia Dodge East 5500 L St. Omaha, NE

Litha East 5500 L St, Omaha, Nebraska

Perimeter Photos

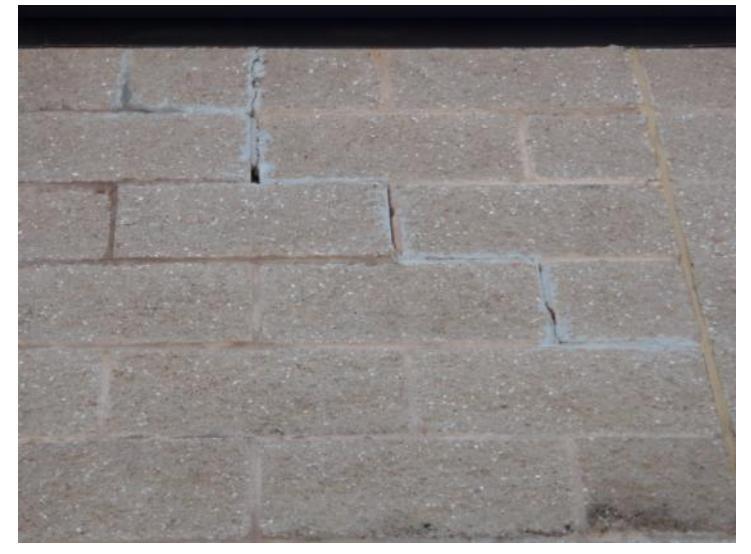
Failed Joints at North Rear Wall

Section 1 should have the existing coping stone secured back on the parapet wall and sealed. Any masonry joints directly below this detail that have failed because of this should be cleaned and sealed as well. The missing roof jack cap on section 1 should be replaced and properly secured. It would also be advisable to add downspout extensions to direct water away from the foundation. The rear block wall should have the few runs of failing joints filled with sealant. Budget number for this work would be \$900.

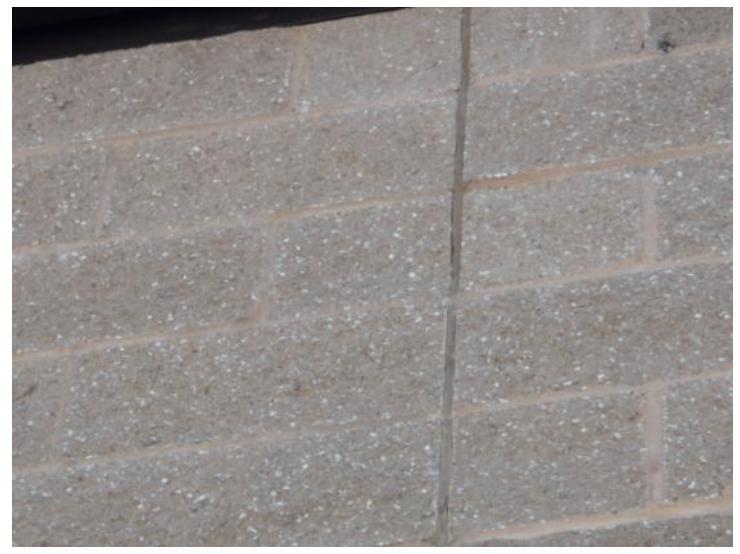
Inadequate Downspout Elbows

Control Joints Look Good

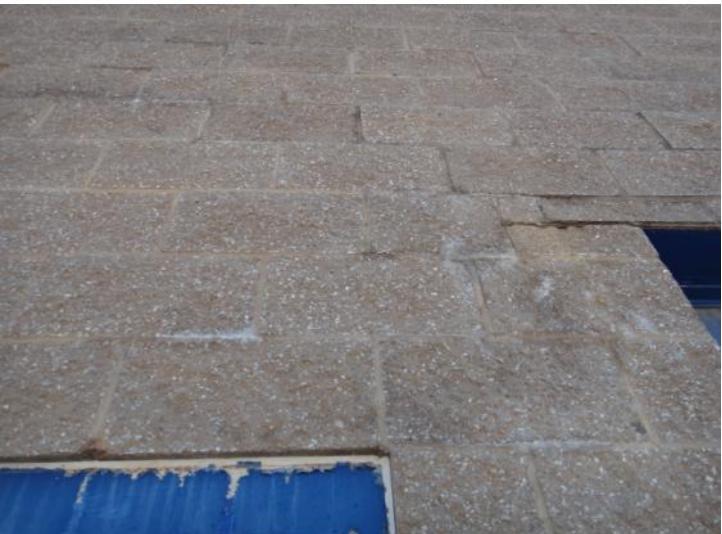
Minor Efflorescence

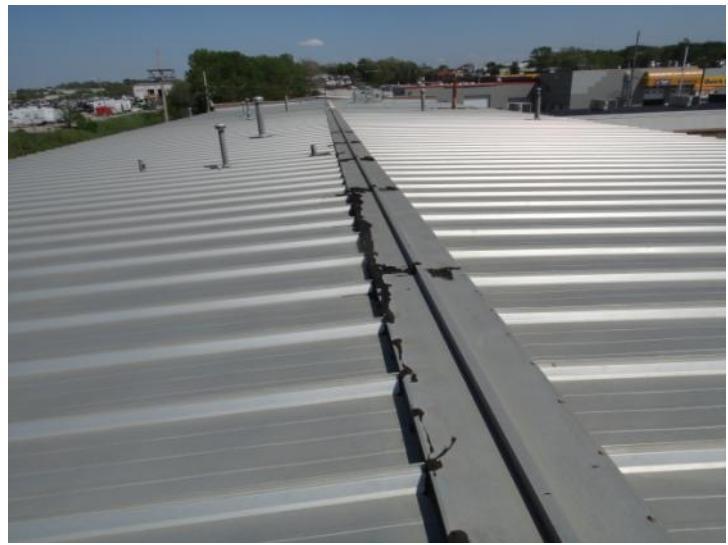
Roof Overview Section 1

Section 1 is in good condition overall. The metal has virtually no rusting and field seams look good. There are fasteners in places that have lifted, but this is not uncommon for a roof of this age. The ridge has gaps where each panel seam enters the ridge cap because the gasket seals of this detail have aged and worn out. Again, this is not uncommon for a roof of this age and does not necessarily mean that leaking is occurring. A **roof jack (furnace stack) cap is missing.** This is certainly letting water into the HVAC system. A **coping stone on the northwest corner has detached and fallen on to the roof field.** This has exposed the parapet wall masonry to water. Water penetration into the masonry can be seen on this corner all the way down the wall with darker wet spots along the top half of the wall and efflorescence (white mist) in the block towards the bottom of the wall. The rear block wall itself is in good condition. Control joints in the block look good. There just a few failed joints just below the gutter run. **Downspouts do not have adequate extensions and water is running along the base of wall**. This is causing erosion along this detail.

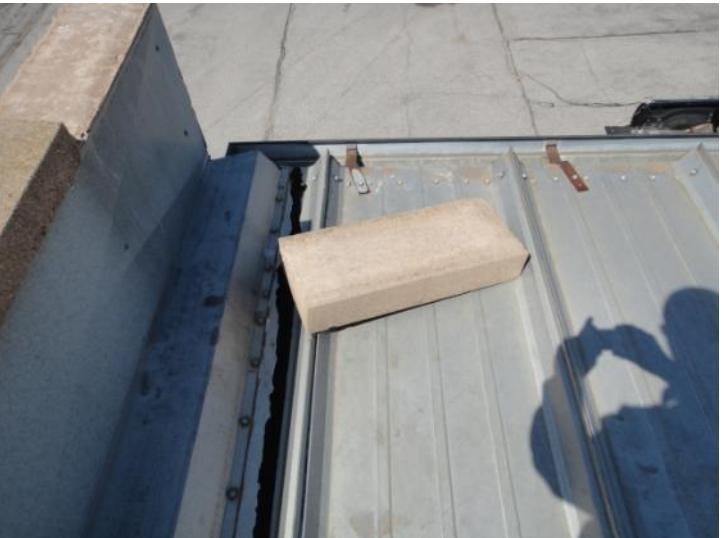
Existing Coping Stone Still Usable

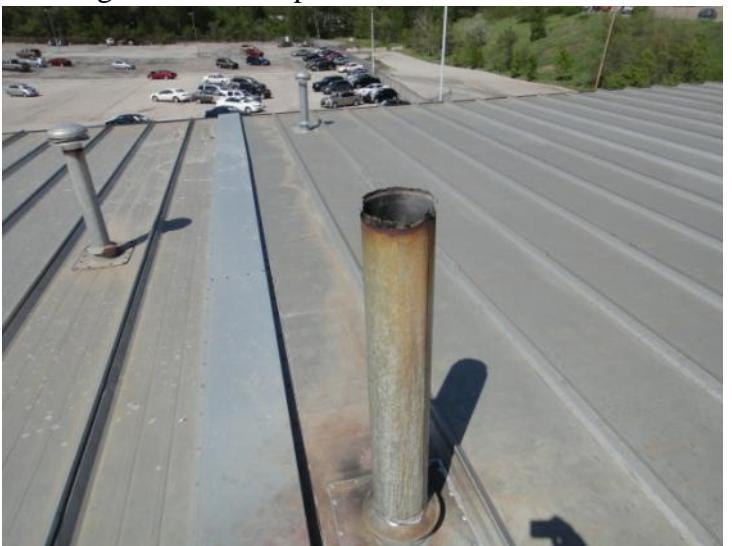
Missing Roof Jack Cap

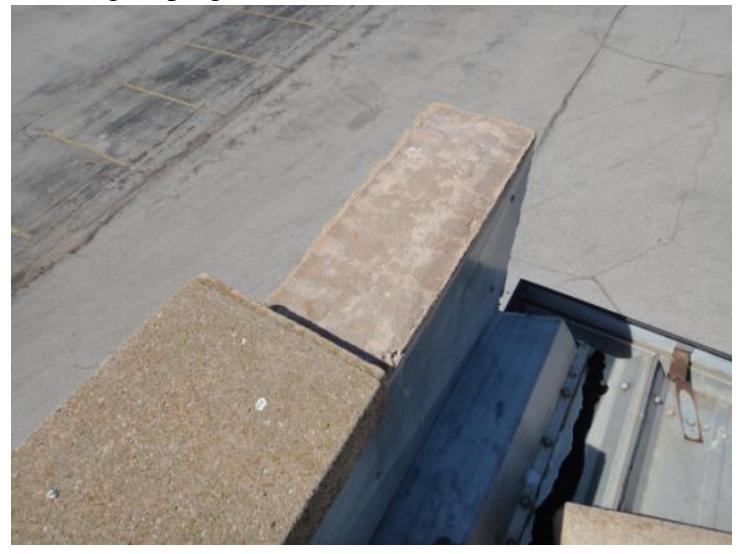
Missing Coping Stone

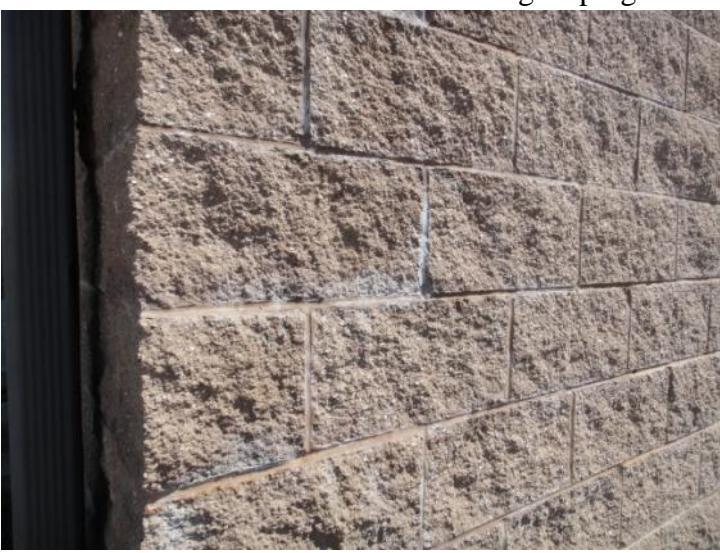
Water Evidence in Block Below Missing Coping

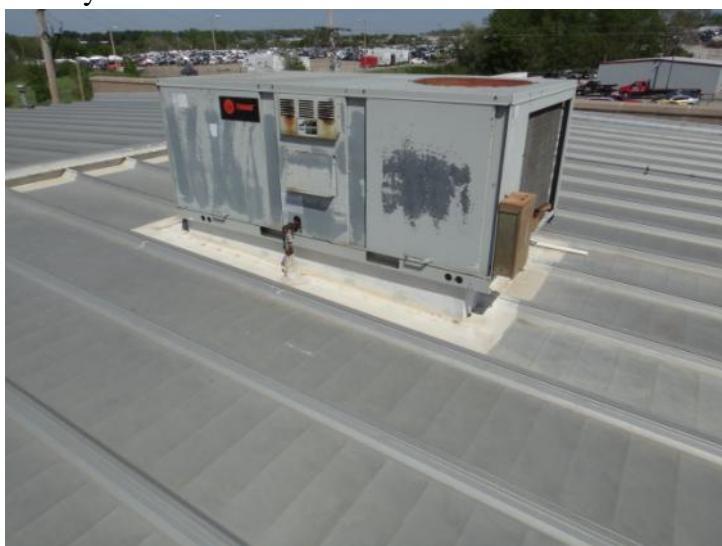
Nicely Flashed and Installed HVAC Details

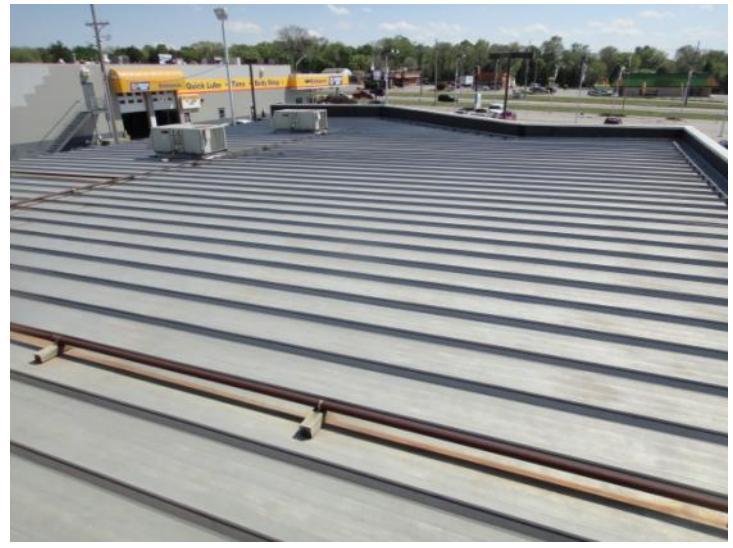
Roof Overview Section 2

Section 2 is in excellent condition. The field is rust free and panel seams look excellent. The parapet walls on this section nicely and properly flashed with EPDM membrane and topped with cap metal. HVAC units were nicely flashed with crickets to direct water around them. A very nice installation.

Section 2 has no immediate work needed.

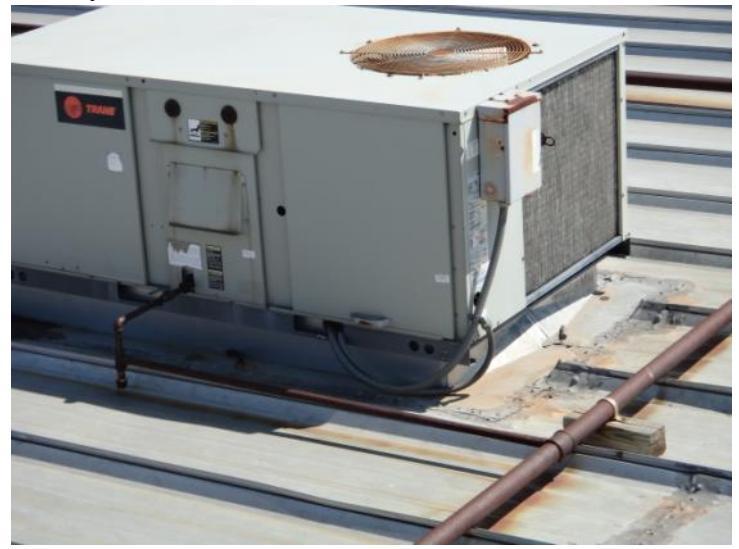
Nicely Flashed and Installed Cap Metal

Nicely Flashed and Installed HVAC Details

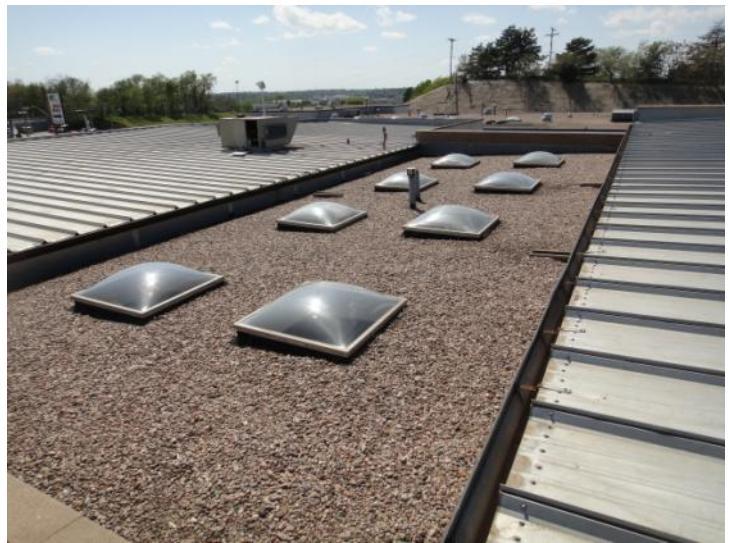
Roof Overview Section 3

Section 3 is in good condition overall. The roof has good slope which really helps a roof's life expectancy. The field is loaded with skylights which is often a liability from a roofing perspective but these were nicely flashed at the time of installation and the skylight metal components look to be in nice shape as well. **Two of these skylight curbs have heavily pulled EPDM membrane. The entire north vertical wall and entire east parapet wall have significantly pulled membrane.** It is pulling to a point where it is pressing against the metal wall flashing above and could cut open in the future. Pulling is very common with Ballasted systems. At the gutter edge, **a metal gravel stop edge was installed along the entire run instead of installing drain bar. This was a poor idea.** The raised 2" edge of the gravel stop negates some of the great roof slope and is causing water to pond along this edge. Slots were cut in, but this is not sufficient and leaves more opportunities for failures in the future. This edge will deteriorate faster than other components of the system, but is acceptable for now. It should be noted that a far better design in the future will be to install a Fully Adhered EPDM system. First of all, the roof's relatively small size would have made upgrading to a fully adhered roof quite inexpensive. This would have eliminated any realistic possibility of pulling (especially with all the curbs that exist on this little roof). Finally, a fully adhered roof would have eliminated the need for drain bar or gravel stop edge at the gutter, allowing clear water flow to the internal gutter. This internal gutter likely has freeze problems in the winter. **Finally, a roof jack cap is missing on this section**.

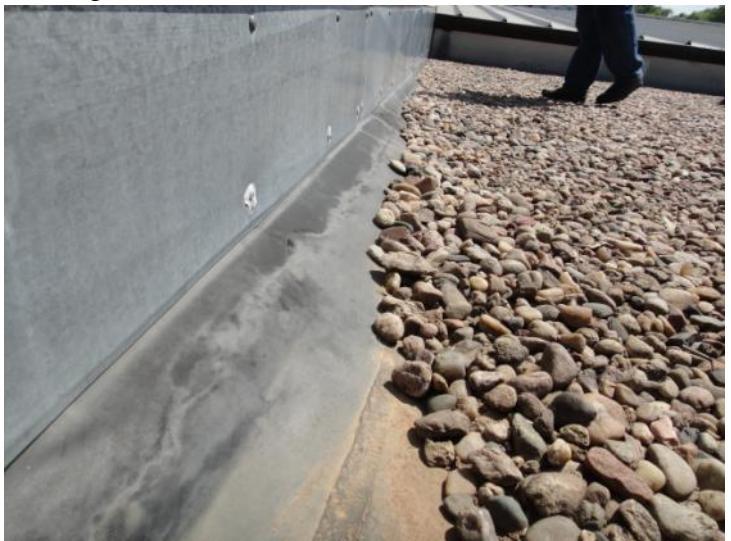
Pulling Membrane at Vertical Wall (East)

Section 3 should have the north and east vertical walls cut open, the membrane relaxed and new membrane installed and tied into the roof field to alleviate the pulling. RPF strip (a strip that uses fasteners and plates drilled into the masonry) should be installed first to pin the new membrane to the wall to help keep the walls from pulling apart in the future. Merely cutting the rubber and gluing in new membrane up the wall is far cheaper but will pull apart again very easily. Two skylight curbs that are pulling should be reflashed in the same manner. The missing roof jack cap should be replaced. A budget number for all repairs on this section would be \$3100.

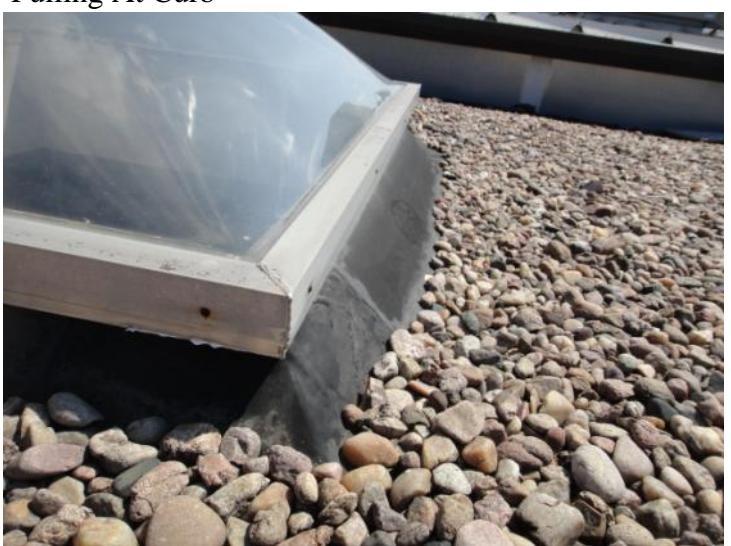
Pulling At Curb

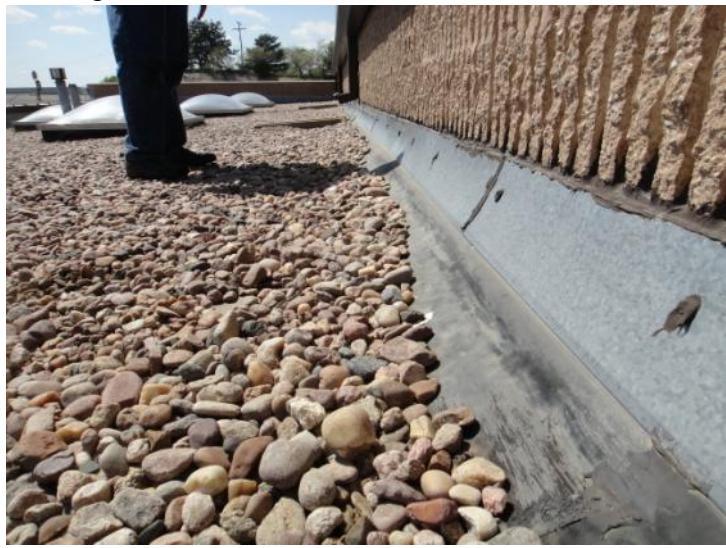
Pulling Membrane at Vertical Wall (North)

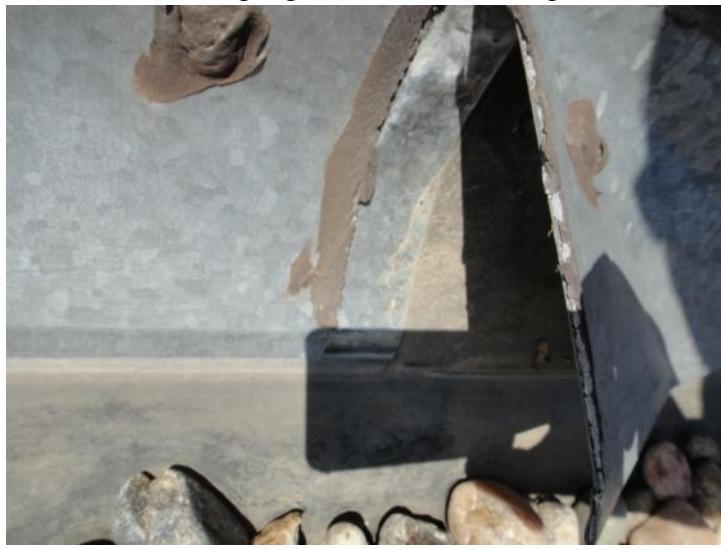
Membrane Pulling Against Metal Flashings

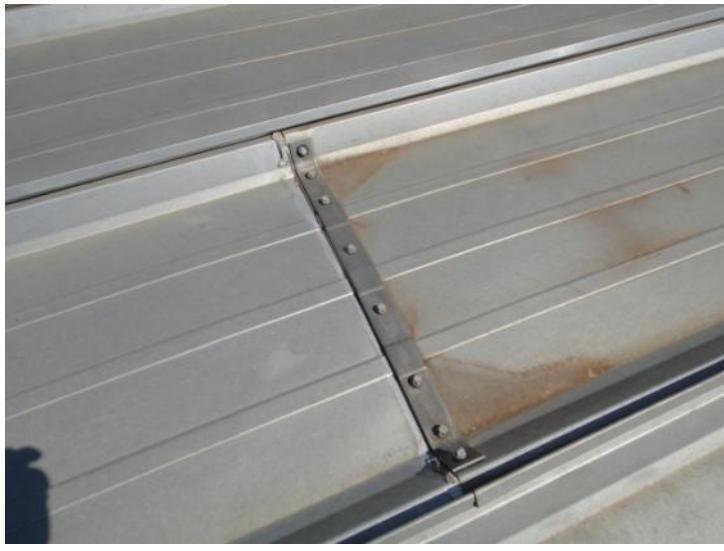
Minor Rusting at Seams (Typical)

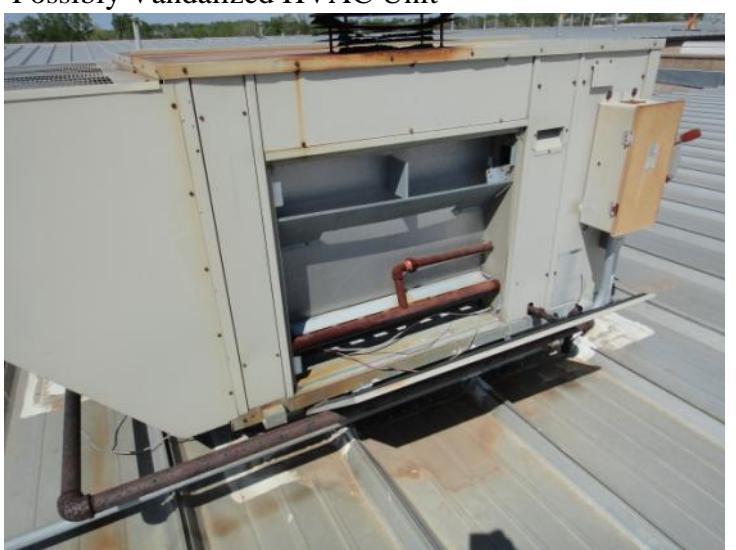
Possibly Vandalized HVAC Unit

Section 4 should have an HVAC contractor inspect the metal panels to insure that they can be properly resecured or they should be replaced. It would be advisable to have the contractor inspect the entire unit as it appears possible that it was vandalism and not wind that caused some of the damage. An extension hose should be installed on the condensation line and it should be run to the gutter to stop the rusting that is being caused on that metal roof panel.

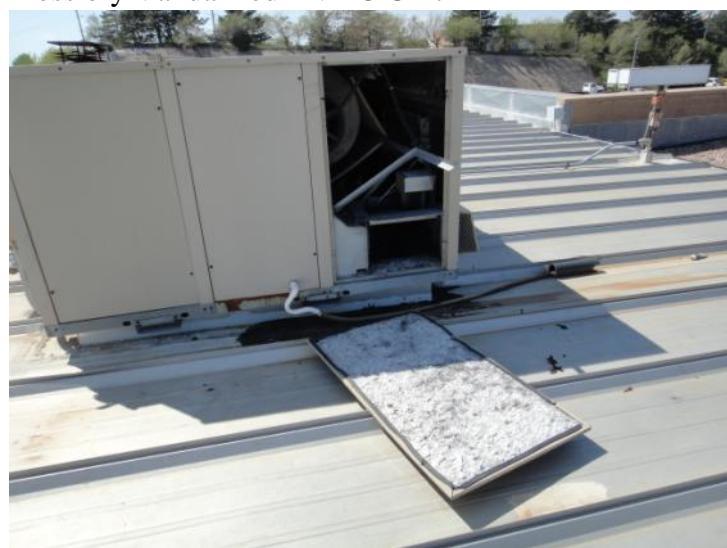
Possibly Vandalized HVAC Unit

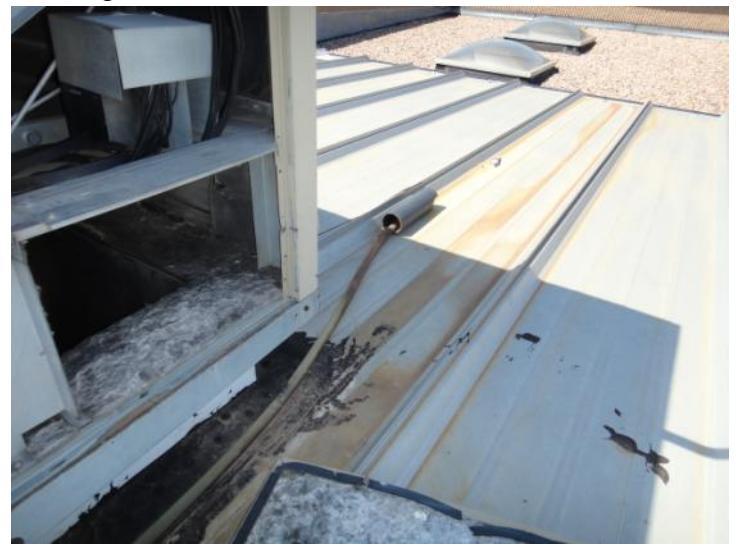
Missing Roof Jack Cap

Rusting Panel Behind HVAC Unit
